- Subject : Ballast box in the fin, foam rubber rings
- Affected : DG-1000S, DG-1000T, all ser.no.'s
- Urgency : prior to next flight and upon changing the trim ballast in the ballast box

This service info has been approved by EASA date 23. April 2008 with technical note DG-G-04.  
Approval No. EASA.A.C.09568.

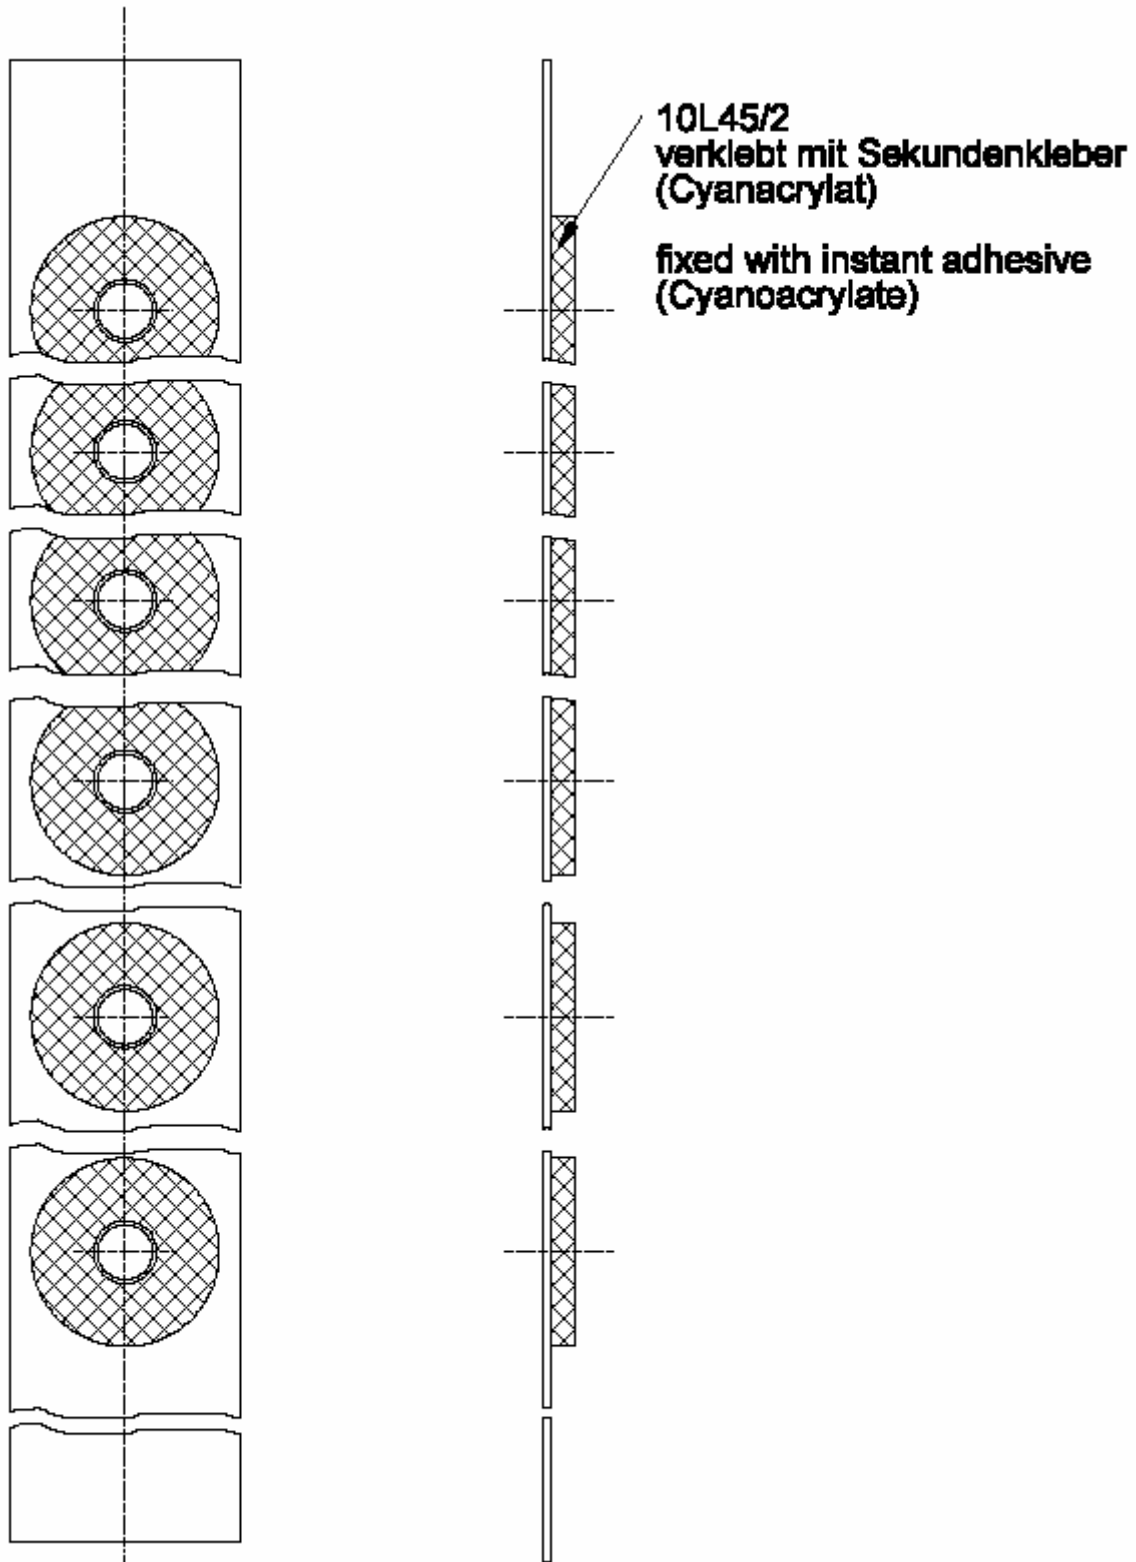
**Assembly drawing for foam rubber rings 10L45/2:**

- Reason : In a DG-1000T a foam rubber ring glued to the mounting plate of the optical sensors for checking the trim ballast has detached. This caused an indication error of the control lamp in the front instrument panel.

2. Remove detached and damaged rings and replace them by new rings according to drawing on page 2. If felt strips are installed, replace them if damaged by foam rings.  
Remove adhesive remains before bonding the new rings.
